CONSIDERATIONS REGARDING THE IMPACT OF THE VIDRARU HYDRO FACILITY ON BIODIVERSITY

Licence Degree in Environmental Studies
Faculty of Geography, University of Bucharest
pravalie_remus@yahoo.com

Considerations regarding the impact of the Vidraru hydro facility on biodiversity

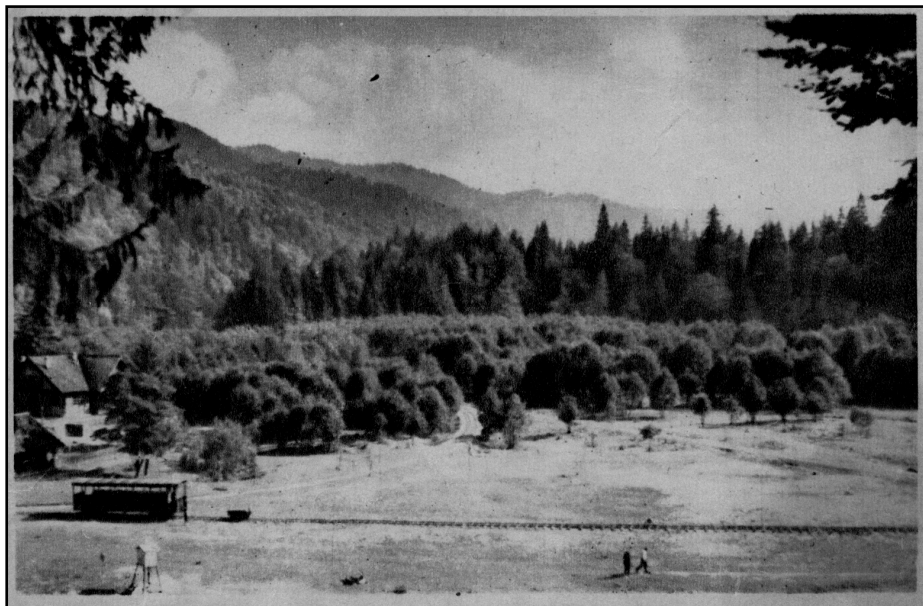
logging was taken over by Argeş Company. It is at this time that the Cumpăna - Curtea de Argeş railway was built, timber logging being made by means of a *mocăniţă*¹ (Photo 1).

Photo 1. Forestry logging before the construction of the dam in the Cumpana area (1947)

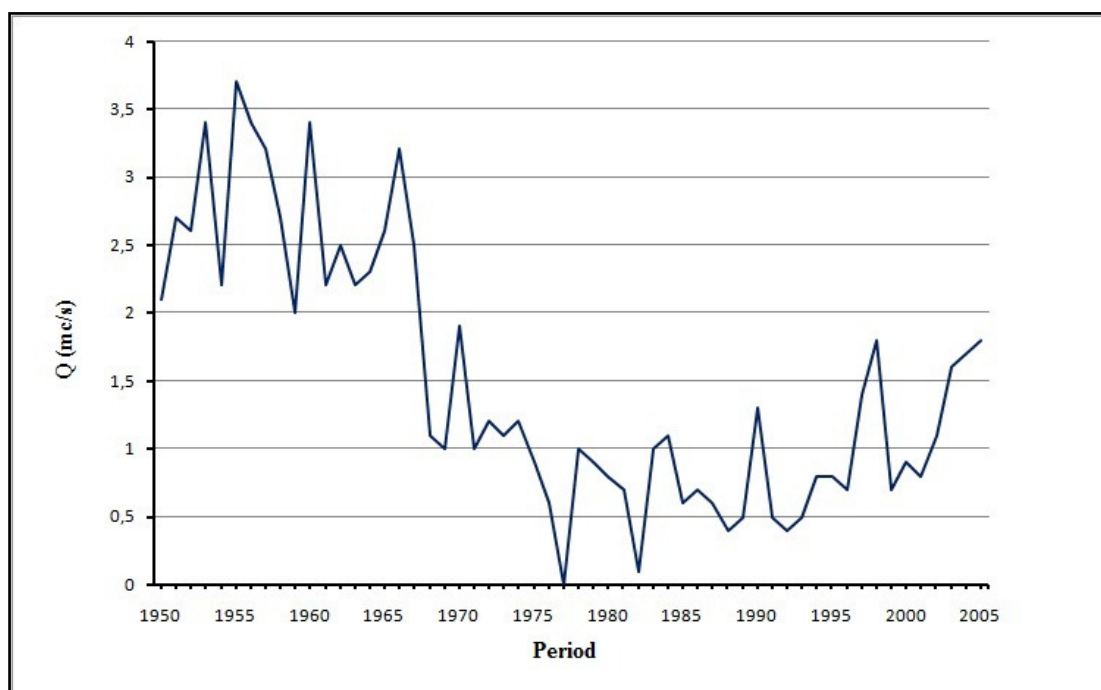
The following picture (Figure 3) presents the variation in the water flow of the Valsan River before and after the emergence of the Valsan Lake. The water flow decreased after 1973, the year the Valsan facility and the main inlet in the Vidraru Reservoir were completed.

Figure 3. Change in the annual average flow (1950-2005) of the Valsan River before and after harnessing the Valsan Lake (data processing Water Board of Arges-Vedea)

As a consequence of the completion of the Cernat – Valea Valsanului – Valea cu Pesti main inlet, the water flow of the Valsan River decreased because a part of the water flow of this river is used to the Vidraru hydropower system. According to research, it was found

that this decrease in river flow caused a fatal impact on the sculpin-perch (*Romanichthys valsanicola*), causing this fish to be on the verge of extinction [11].
