DAMBOVITA – 50 KM BETWEEN GOOD QUALITY AND ECOLOGICAL DISASTER

Dumitru MORCOTEȚ
Nina JIPA
Liudmila Maria MEHEDINȚEANU

Master in Geography
Faculty of Geography, University of Bucharest
morcotet_dumitru@yahoo.com, jipa.nina@yahoo.com,
mehedinteanuliudmila@yahoo.com

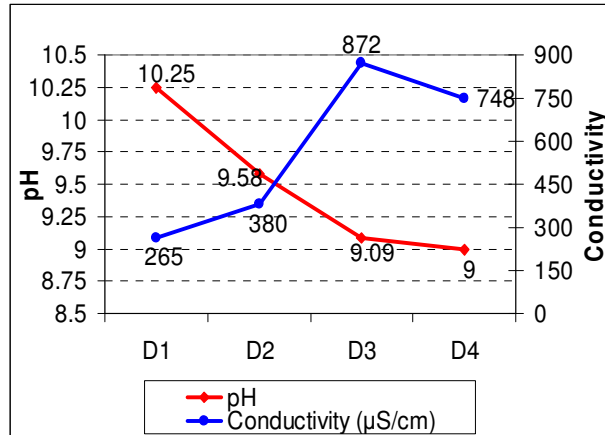
Figure 4: The pH and electrical conductivity

In what follows, we will analyze the causes of changes in the physical and chemical water properties between points D2 and D3, a representative section for the water quality degradation process of Dambovita's waters in the Bucharest area. Regarding the pH (Figure no. 4), there is a high initial value, which classifies the river's waters in the category of alkaline ones, indicating a high content of carbonates [12], which is then reduced towards a slightly alkaline one, due to the contribution of waters containing acidic substances (hydrochloric acid, nitric, sulfuric, acetic acid), derived from industrial sources [3] [5].

Regarding the electrical conductivity (Figure no. 4), an increase of more than two times the values of the two points can be noticed, which indicates a sharp increase in concentration of salts dissolved in water, from industrial sources (mineral salts) and domestic (especially sodium chloride) [3]. Large increases can be also detected for the total dissolved substances indicator (Figure no. 5) (about two times), which is in agreement with the previous indicator, salts holding a significant share in the category of substances dissolved in water. The increasing trend is valid for turbidity (Figure no. 5), but with a much higher intensity (higher values of about eight times in point D3 than in D2), that leads

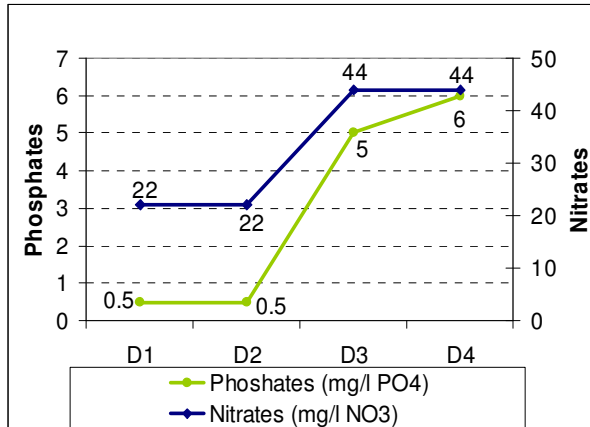
Figure 6: Nitrates and phosphates

Regarding the nutrient concentrations in the water (Figure no. 6), increases between the two points for both nitrates and phosphates can be noticed, more pronounced, however, in the case of the latter, for which values are increased tenfold.

The increase of nitrate content in the water is mainly due to bacterial oxidation of organic matter, especially those of animal origin, derived from both industrial (especially food industry) but also domestic sources [12]. Taking into consideration the phosphates, the increases arise as a result of polyphosphate detergent and dejection uploads from the domestic wastewaters flowing into Dambovita [12].

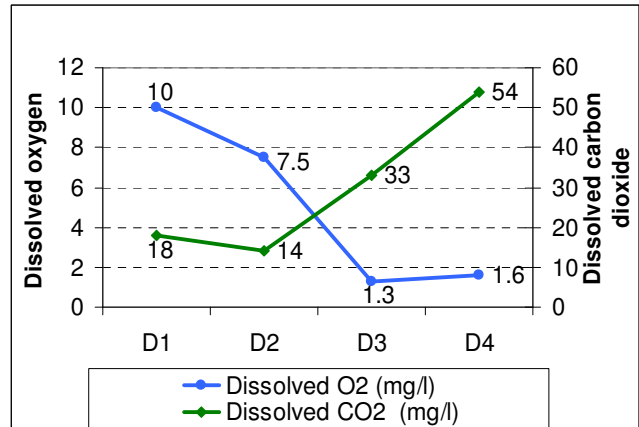
Figure 7: Dissolved oxygen and carbon dioxide

Looking at the main dissolved gases from the surface waters, oxygen and carbon dioxide, respectively, an inverse trend is observed at the two parameter's values (Figure no. 7), the first one shows decreases (almost six times), and the second increases (more than twice) between the two points D2 and D3. The main causes for the decrease of oxygen are the oxidation of organic substances in the water (anaerobic fermentation of organic waste) and the processes of decomposition of proteins from domestic waters [12]. The increases found for carbon dioxide arise because of the fermentation of decomposed organic waste from the domestic waters, also due to the waters rich in this gas in this case as a result of industrial activities, such as the food industry [12].

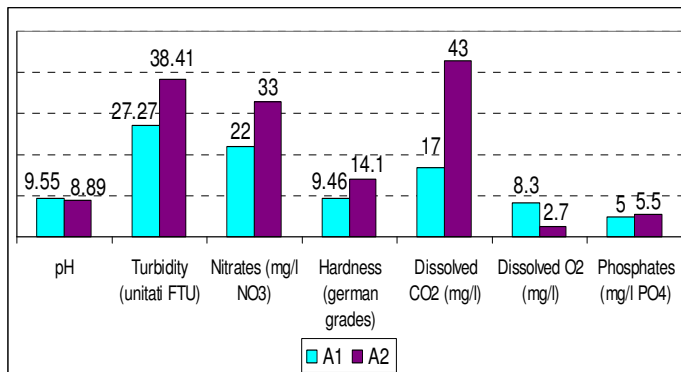
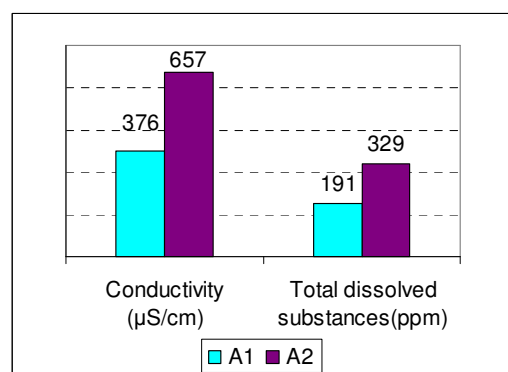
According to the results of our determinations for the river Arges, summarized in Figures 9 and 10, it is considered that the degraded waters of Dambovita have a negative influence on its collector. Thus, increases in the values for turbidity, electrical conductivity, total dissolved substances, nutrients, hardness and dissolved carbon dioxide can be observed, as well as decreases in the case of pH and dissolved oxygen. These changes are explained by the intake of Dambovita waters that records exceeded values of the quality indicators in the category of oxygen, nutrients and organic micro pollutants [1]. Therefore, the water quality at the point A2 is lower than in A1, but higher than the D4 point, because of the river's flow greater than that of Dambovita, providing a more intense dilution of pollutants. Using, as in the previous case the dissolved oxygen indicator for determining water quality's class, we obtained the category II for the A1 point and the category V for the A2 point.

Figure no. 9: Results for determinations at A1 and A2 points (I)

Figure no. 10: Results for determinations at A1 and A2 points (II)

- Arges's waters pass from class II of quality to class IV after the junction with Dambovita, due to the overruns discovered in the nutrients group;
- Budești's underground waters are altered by infiltrations from Dâmbovița progressively as the distance from it decreases;

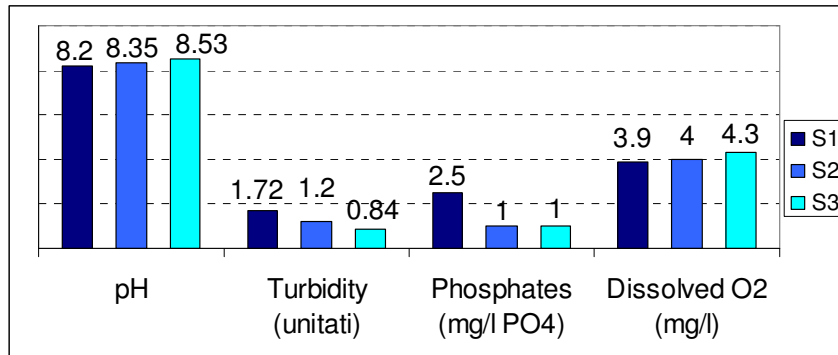
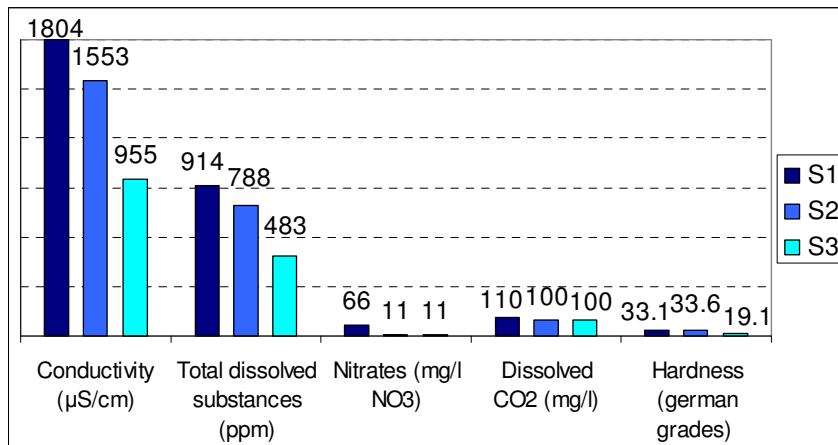
According to the results of our measurements in the case of ground waters in the city Budeşti, it is considered that infiltration from Dambovita influence the groundwater's quality, detecting a slight degradation as the points of measurements approach the river (Figure no. 11 Figure No. 12). Thus, between the point S3, the most distant, and S1, the closest to Dambovita, a progressive increase in the indicators values for turbidity, conductivity, total dissolved hardness, nutrients and dissolved carbon dioxide and a

progressive decrease in pH and dissolved oxygen, can be noticed. However, due to the filtration that the water undergoes when passing through sand and gravel specific to this area, water samples collected from all three points fit the drinking limits, under the 458/2002 Law (Law on drinking water quality). Moreover, it is estimated that the infiltrations from Dambovita contaminate the groundwater, making the water unfit for human use, over a distance of about 100 m from the river [11]. The only problem posed is because of high hardness of the ground waters that exceeds 30 ° German at two points, which could be explained by the washing of clays present in the region’s substrate in question [12]. It is worth mentioning that the city’s residents of Budesti supply themselves with water derived from the centralized system, its origins being the deep ground waters at a distance of about 1.5 km from Dambovita.

Figure 11. Measurement result for S1, S2 and S3 points (I)

Figure 12. Measurement results for S1, S2 and S3 points (II)

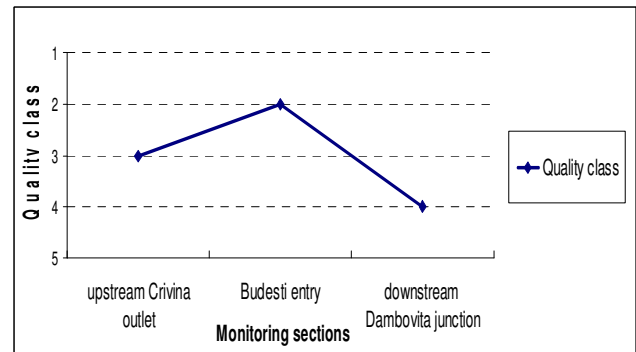
According to the determinations made within the national network for monitoring surface water quality on Dambovita and Arges rivers in the Bucharest area [8], the results are summarized in Figure no. 13 and no. 14. Looking at the river Dambovita an oscillation of the water quality state stands out in the Brezoaiele - Popesti section, between class II and III, due to a diffuse nutrient pollution from agricultural sources [1]. In contrast, between the sections Popesti and Balaceanca, section in which the discharge of untreated wastewaters from Glina takes place, there is a strong degradation of the quality status, waters becoming classified in the class V, because of registered overruns of the oxygen regime, nutrients and organic micro pollutants indicators, a situation that remains the same until the junction with Arges [1]. In the latter case, the degraded waters of Dambovita cause the decrease of water quality between the points located upstream (II quality class) and downstream (IV quality class) of the two river's junction. Therefore, the results obtained from water quality monitoring within the national network are consistent with those extracted from our own determinations.

Figure 13. The evolution of Dambovita's water Bucharest municipality in 2009

Figure 14. The evolution of Arges' quality in the are water quality before and after the junction with Dambovita in 2009
